**Flood Control Project Maintenance  
Levee Inspections**  
**LMA District Cover Sheet**  
**Spring 2020 Levee Inspection Results**

**Reclamation District No. 1001 Nicolaus**

**Spring 2020 Levee Inspection Results**

**Levee Inspection Report By Mile - Spring 2020**

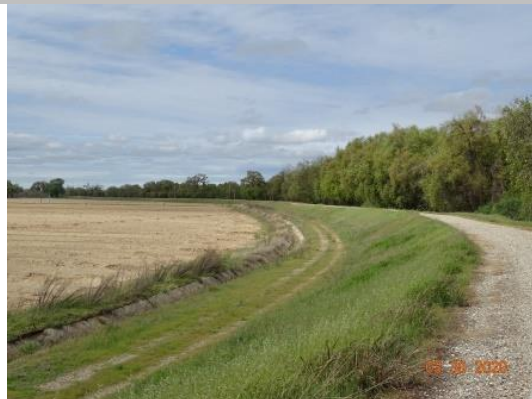
Photo 1 of 1 : SP\_2020\_RD1001\_36\_10\_20200406\_00017.jpg

LM Start	0.01	Rating **	A	Issue No.	10
LM End	4.10	Issue Type +	Ma	Location *	LS
Category	Earthen Levee			GPS Latitude/Longitude	
				Start	End
Item	Vegetation			38.980182 °	38.970514 °
				-121.470263 °	-121.534444 °
DWR ID	DWR_RD1001_01_s_2020_10				
Comment Code					
V1 : Control annual grass and weeds on the levee slopes and easements.					
Inspector Comment					
The annual vegetation is well maintained, Spring 2020.

View looking upstream landside at the well maintained annual vegetation, Spring 2020.

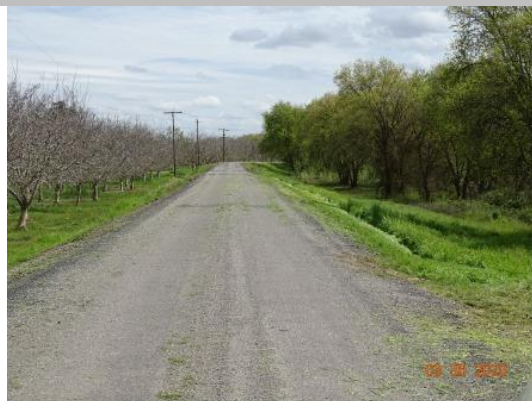
Photo 1 of 1 : SP\_2020\_RD1001\_36\_11\_20200406\_00016.jpg

LM Start	0.01	Rating **	A	Issue No.	11
LM End	4.10	Issue Type +	Ma	Location *	WS
Category	Earthen Levee			GPS Latitude/Longitude	
				Start	End
Item	Vegetation			38.980182 °	38.970514 °
				-121.470263 °	-121.534444 °
DWR ID	DWR_RD1001_01_s_2020_11				
Comment Code					
V1 : Control annual grass and weeds on the levee slopes and easements.					
Inspector Comment					
The annual vegetation is well maintained, Spring 2020.

View looking upstream waterside at the well maintained annual vegetation, Spring 2020.

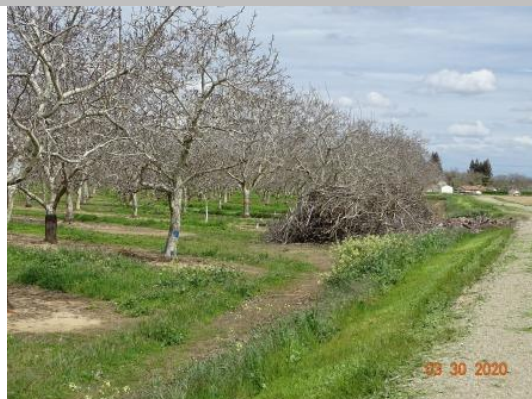
Photo 1 of 1 : SP\_2020\_RD1001\_36\_26\_20200406\_00019.jpg

LM Start	0.37	Rating **	U	Issue No.	26
LM End	0.37	Issue Type +	En	Location *	LS
Category	Earthen Levee			GPS Latitude/Longitude	
				Start	End
Item	Encroachments			38.976294 °	38.976294 °
				-121.474524 °	-121.474524 °
DWR ID	DWR_RD1001_01_f _ 2016_26				
Comment Code					
PR : Prunings					
Inspector Comment					
Remove prunings from levee toe, Spring 2020.

View of prunings on landside toe looking upstream, Spring 2020.

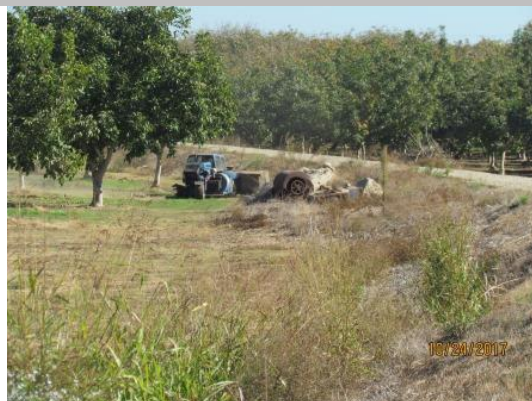
Photo 1 of 1 : SP\_2020\_RD1001\_36\_16\_20200227\_00010.jpg

LM Start	0.42	Rating **	M	Issue No.	16
LM End	0.42	Issue Type +	En	Location *	LS
Category	Earthen Levee			GPS Latitude/Longitude	
				Start	End
Item	Encroachments			38.975782 °	38.975782 °
				-121.475321 °	-121.475321 °
DWR ID	DWR_RD1001_01_s_2015_16				
Comment Code					
DE : Debris					
Inspector Comment					
Remove debris from levee toe, Spring 2020.

View looking upstream at concrete debris on landside slope.

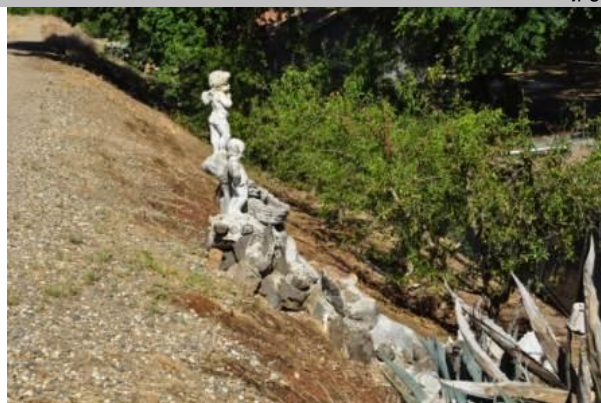
Photo 1 of 2 : SP\_2020\_RD1001\_36\_5\_20200227\_00002.jpg

LM Start	3.12	Rating **	M	Issue No.	5
LM End	3.17	Issue Type +	En	Location *	LS
Category	Earthen Levee			GPS Latitude/Longitude	
				Start	End
Item	Vegetation			38.965663 °	38.965705 °
				-121.521023 °	-121.522098 °
DWR ID	DWR_RD1001_01_s_2012_5				
Comment Code					
V6 : Landscaping					
Inspector Comment

Unit 1 Landscaping on landside levee slope.

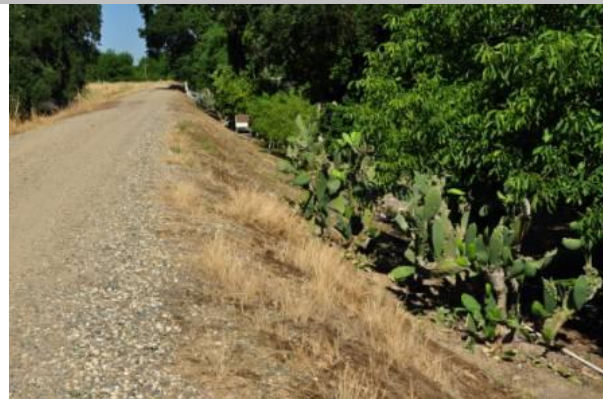
Photo 2 of 2 : SP\_2020\_RD1001\_36\_5\_20200227\_00003.jpg

LM Start	3.12	Rating **	M	Issue No.	5 (cont)
LM End	3.17	Issue Type +	En	Location *	LS
Category	Earthen Levee			GPS Latitude/Longitude	
				Start	End
Item	Vegetation			38.965663 °	38.965705 °
				-121.521023 °	-121.522098 °
DWR ID	DWR_RD1001_01_s_2012_5

View of landscaping on landside slope.

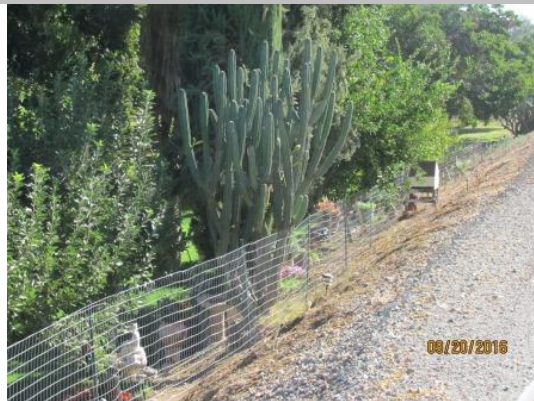
Photo 1 of 1 : SP\_2020\_RD1001\_36\_20\_20200227\_00011.jpg

LM Start	3.13	Rating **	M	Issue No.	20
LM End	3.17	Issue Type +	En	Location *	LS
Category	Earthen Levee			GPS Latitude/Longitude	
				Start	End
Item	Encroachments			38.965663 °	38.965672 °
				-121.521267 °	-121.521919 °
DWR ID	DWR_RD1001_01_f_2016_20				
Comment Code					
FE : Fence					
Inspector Comment					
Land owner has installed an unpermitted fence on the landside levee slope.

View of a fence on the landside levee slope looking upstream.

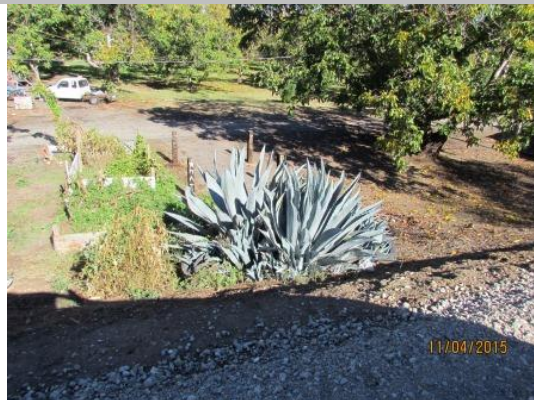
Photo 1 of 1 : SP\_2020\_RD1001\_36\_4\_20200227\_00001.jpg

LM Start	3.21	Rating **	U	Issue No.	4
LM End	3.21	Issue Type +	En	Location *	LS
Category	Earthen Levee			GPS Latitude/Longitude	
				Start	End
Item	Vegetation			38.965699 °	38.965699 °
				-121.522790 °	-121.522790 °
DWR ID	DWR_RD1001_01_f_2015_4				
Comment Code					
V6 : Landscaping					
Inspector Comment

View of the landscaping at the landside levee toe.

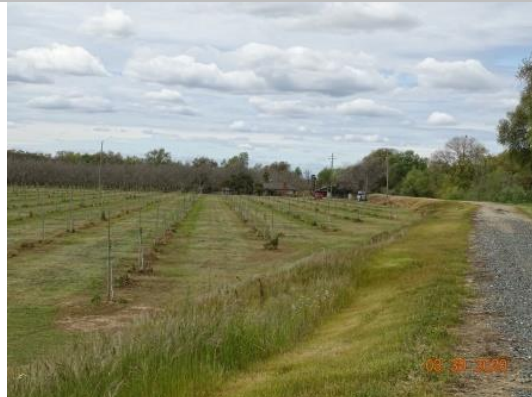
Photo 1 of 1 : SP\_2020\_RD1001\_35\_9\_20200406\_00024.jpg

LM Start	0.01	Rating **	A	Issue No.	9
LM End	3.62	Issue Type +	Ma	Location *	LS
Category	Earthen Levee			GPS Latitude/Longitude	
				Start	End
Item	Vegetation			38.971342 °	38.965658 °
				-121.473997 °	-121.533276 °
DWR ID	DWR_RD1001_02_s _ 2020_9				
Comment Code					
V1 : Control annual grass and weeds on the levee slopes and easements.					
Inspector Comment					
The annual vegetation is well maintained, Spring 2020.

View looking downstream landside at the well maintained annual vegetation, Spring 2020.

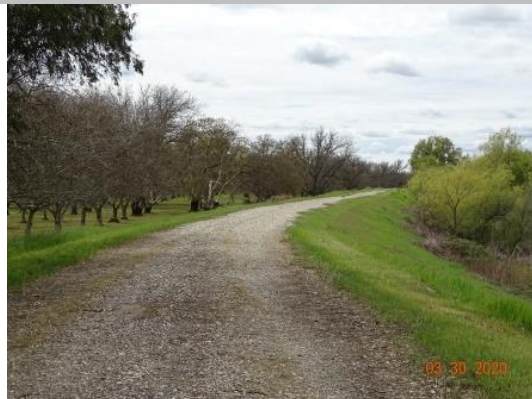
Photo 1 of 1 : SP\_2020\_RD1001\_35\_14\_20200406\_00025.jpg

LM Start	0.01	Rating **	A	Issue No.	14
LM End	3.62	Issue Type +	Ma	Location *	WS
Category	Earthen Levee			GPS Latitude/Longitude	
				Start	End
Item	Vegetation			38.971342 °	38.965658 °
				-121.473997 °	-121.533276 °
DWR ID	DWR_RD1001_02_s _ 2020_14				
Comment Code					
V1 : Control annual grass and weeds on the levee slopes and easements.					
Inspector Comment					
The annual vegetation is well maintained, Spring 2020.

View looking downstream waterside at the well maintained annual vegetation, Spring 2020.

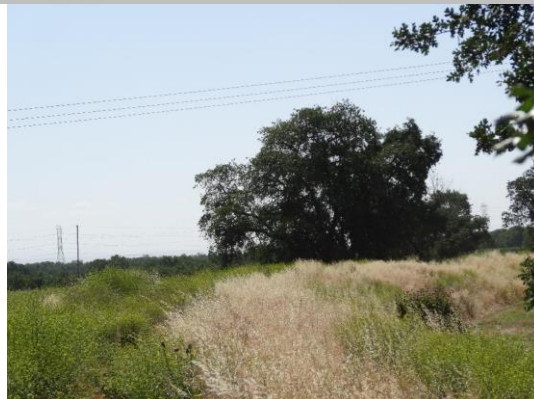
Photo 1 of 3 : UCIP\_SP\_2020\_41673\_22745.jpg

Comment Code					
Inspector Comment					
DS_ID:22536 FS_ID:41673 EP_NO: 5562 Repair Type: Non-Urgent Crossing Status: Found UCIP Comments: 05/23/2013 Pipe appears abandoned and if so should be done so properly. WS pipe plugged with stopper. Seems abandoned. Only abandoned pump base found. (P. Amatya - DWR UCIP) FIELD_STRUCT_DESC: 6-inch coated steel irrigation pipe through the levee, 3.5 feet below the crown. Metal cutoff collar placed on the pipe at the center of the levee crown. Pump was removed. Pump base on the waterside (WS) berm. Shutoff valve on the discharge side of the pump. Foot valve below water on the intake side of the pump. Siphon breaker on the landside (LS) shoulder. Pipe discharges into underground irrigation system on the LS. Power pole and meter box, 10 feet from the landward toe. 1.5-inch flexible conduit through levee, 3.5 feet below the crown. (Pump and 6-inch irrigation pipe authorized under Permit No. 5562, 1966 - Samuel B. Single). [Additional Reference(s): DWR Levee Log, 1993]. FS Date: 5/23/2013

Levee Crown: dense vegetation on levee crown and sides.

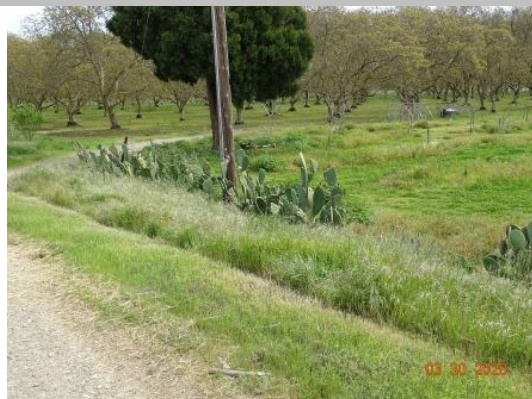
Photo 1 of 1 : SP\_2020\_RD1001\_35\_7\_20200406\_00027.jpg

LM Start	0.54	Rating **	M	Issue No.	7
LM End	0.54	Issue Type +	En	Location *	LS
Category	Earthen Levee			GPS Latitude/Longitude	
				Start	End
Item	Vegetation			38.974346 °	38.974346 °
				-121.481425 °	-121.481425 °
DWR ID	DWR_RD1001_02_s_2020_7				
Comment Code					
V6 : Landscaping					
Inspector Comment					
Remove landscape vegetation from levee slope, Spring 2020.

View looking upstream landside at landscape vegetation at levee toe, Spring 2020.

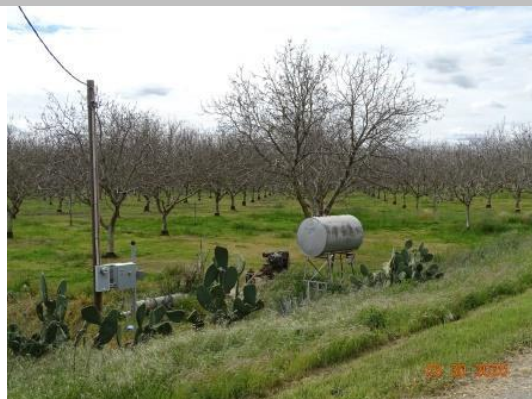
Photo 1 of 1 : SP\_2020\_RD1001\_35\_21\_20200406\_00028.jpg

LM Start	0.54	Rating **	M	Issue No.	21
LM End	0.54	Issue Type +	En	Location *	LS
Category	Earthen Levee			GPS Latitude/Longitude	
				Start	End
Item	Encroachments			38.974348 °	38.974348 °
				-121.481498 °	-121.481498 °
DWR ID	DWR_RD1001_02_f_2016_21				
Comment Code					
TA : Tank					
Inspector Comment					
Tank at landside levee toe needs to be removed from easement, Spring 2020.

View looking downstream landside at fuel tank, Spring 2020.

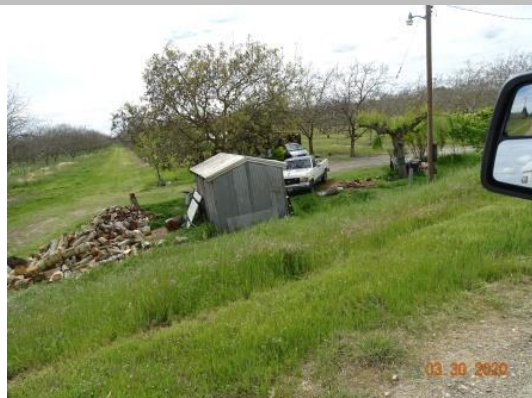
Photo 1 of 1 : SP\_2020\_RD1001\_35\_8\_20200406\_00029.jpg

LM Start	0.63	Rating **	M	Issue No.	8
LM End	0.63	Issue Type +	En	Location *	LS
Category	Earthen Levee			GPS Latitude/Longitude	
				Start	End
Item	Encroachments			38.974201 °	38.974201 °
				-121.483010 °	-121.483010 °
DWR ID	DWR_RD1001_02_s_2020_8				
Comment Code					
BU : Building					
Inspector Comment					
Shed at levee toe, Spring 2020.

View looking landside of a shed at levee toe, Spring 2020.

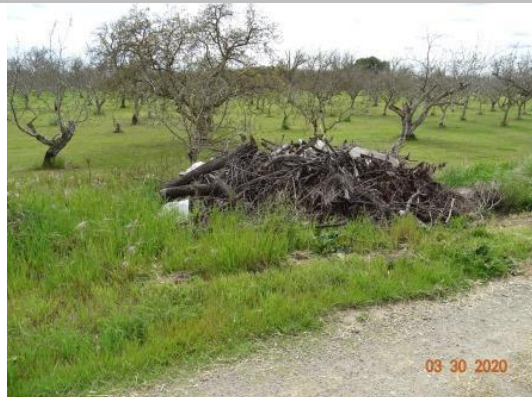
Photo 1 of 1 : SP\_2020\_RD1001\_35\_22\_20200406\_00030.jpg

LM Start	0.78	Rating **	M	Issue No.	22
LM End	0.78	Issue Type +	En	Location *	LS
Category	Earthen Levee			GPS Latitude/Longitude	
				Start	End
Item	Encroachments			38.973509 °	38.973509 °
				-121.485668 °	-121.485668 °
DWR ID	DWR_RD1001_02_f _ 2016_22				
Comment Code					
DE : Debris					
Inspector Comment					
Debris has been piled up, Spring 2020.

View of debris pile on the landside levee slope looking downstream, Spring 2020.

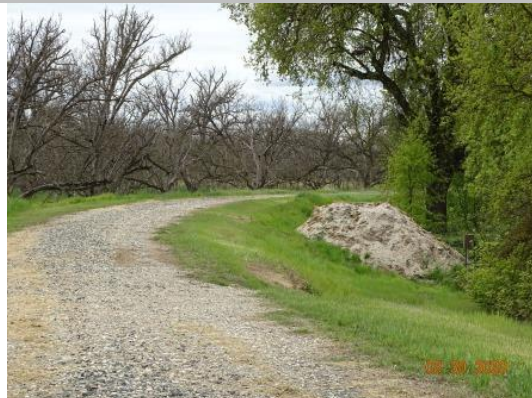
Photo 1 of 1 : SP\_2020\_RD1001\_35\_12\_20200406\_00031.jpg

LM Start	1.31	Rating **	M	Issue No.	12
LM End	1.31	Issue Type +	En	Location *	WS
Category	Earthen Levee			GPS Latitude/Longitude	
				Start	End
Item	Encroachments			38.969830 °	38.969830 °
				-121.493994 °	-121.493994 °
DWR ID	DWR_RD1001_02_s_2015_12				
Comment Code					
MA : Material					
Inspector Comment					
Sand pile needs to be removed from waterside slope, Spring 2020.

View of a pile of soil on the waterside slope looking downstream, Spring 2020.

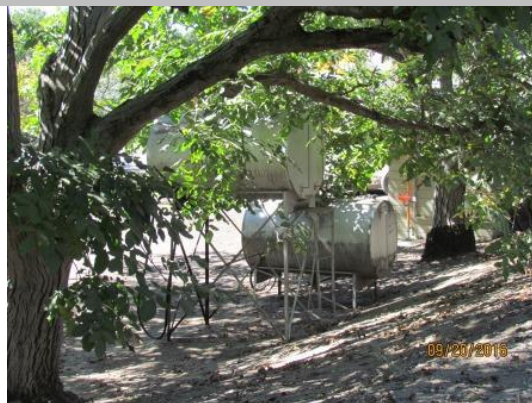
Photo 1 of 1 : SP\_2020\_RD1001\_35\_23\_20200227\_00012.jpg

LM Start	1.70	Rating **	M	Issue No.	23
LM End	1.70	Issue Type +	En	Location *	LS
Category	Earthen Levee			GPS Latitude/Longitude	
				Start	End
Item	Encroachments			38.970260 °	38.970260 °
				-121.501246 °	-121.501246 °
DWR ID	DWR_RD1001_02_f_2016_23				
Comment Code					
TA : Tank					
Inspector Comment					
Two tanks are at the landside levee toe and should be moved from the easement.

View of two tanks that are at the landside levee toe.

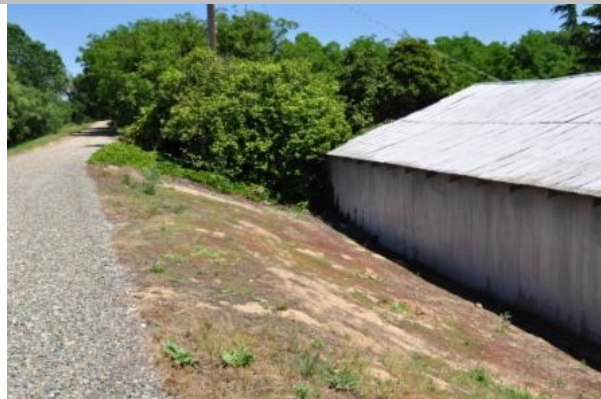
Photo 1 of 1 : SP\_2020\_RD1001\_35\_10\_20200227\_00003.jpg

LM Start	1.74	Rating **	U	Issue No.	10
LM End	1.74	Issue Type +	En	Location *	LS
Category	Earthen Levee			GPS Latitude/Longitude	
				Start	End
Item	Vegetation			38.970353 °	38.970353 °
				-121.501935 °	-121.501935 °
DWR ID	DWR_RD1001_02_s_2012_10				
Comment Code					
V6 : Landscaping					
Inspector Comment

RD 1001 Unit 2 - L/S -Landscaping - Trees

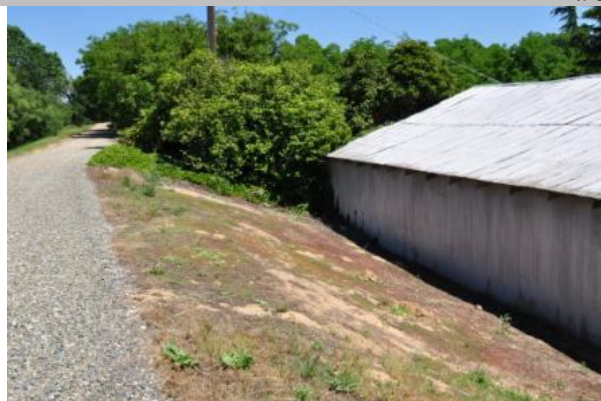
Photo 1 of 1 : SP\_2020\_RD1001\_35\_11\_20200227\_00004.jpg

LM Start	1.75	Rating **	U	Issue No.	11
LM End	1.75	Issue Type +	En	Location *	LS
Category	Earthen Levee			GPS Latitude/Longitude	
				Start	End
Item	Encroachments			38.970347 °	38.970347 °
				-121.502027 °	-121.502027 °
DWR ID	DWR_RD1001_02_s_2012_11				
Comment Code					
BU : Building					
Inspector Comment

View looking upstream landside at an unpermitted building at levee toe.

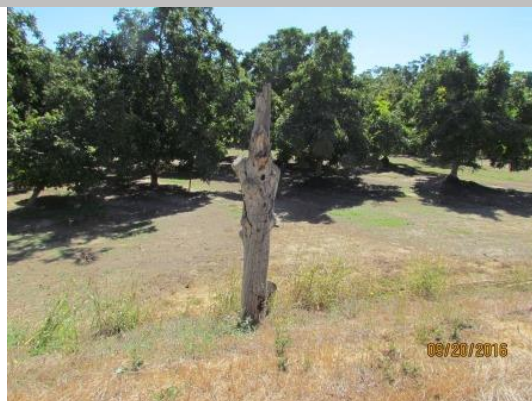
Photo 1 of 1 : SP\_2020\_RD1001\_35\_6\_20200227\_00002.jpg

LM Start	1.88	Rating **	M	Issue No.	6
LM End	1.88	Issue Type +	En	Location *	LS
Category	Earthen Levee			GPS Latitude/Longitude	
				Start	End
Item	Encroachments			38.969489 °	38.969489 °
				-121.504155 °	-121.504155 °
DWR ID	DWR_RD1001_02_f_2015_6				
Comment Code					
TR : Tree or limb					
Inspector Comment					
The farmer will not allow these stumps to be removed at this time, Spring 2020.

View of large stump at the landside levee toe.

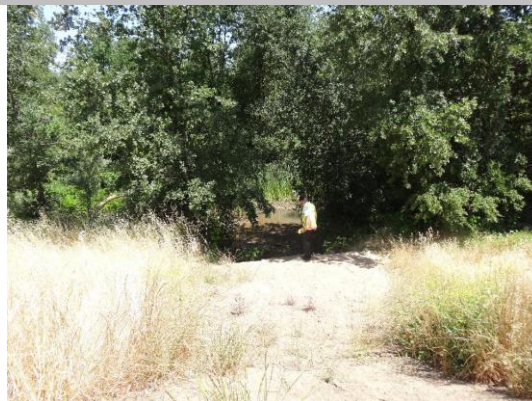
Photo 1 of 3 : UCIP\_SP\_2020\_14008\_23108.jpg

Comment Code						
Inspector Comment						
DS_ID:22543 FS_ID:14008 EP_NO: N/A Repair Type: Non-Urgent Crossing Status: Found UCIP Comments: 05/23/2013 - slide gate in inlet pipe on landside - pits on pipe due to corrosion (P. Amatya - DWR UCIP) FIELD_STRUCT_DESC: 36-inch corrugated metal gravity drainage pipe through the levee, 15 feet below the crown. Flap gate and concrete U-shaped headwall at outfall on the waterside (WS) end. Slide gate at inlet on the landside (LS) end. (Reclamation District No. 1001). [Additional Reference(s): DWR Levee Log, 1993. USACE Sacramento O&M Manual 141.1, August 1955, (Station 67+75)]. FS Date: 5/23/2013

WS- overview of waterside of the levee.

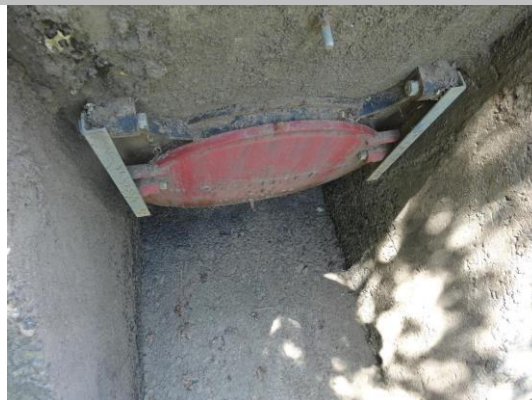
Photo 2 of 3 : UCIP\_SP\_2020\_14008\_23107.jpg

WS- outfall pipe with flap gate in concrete wing wall.

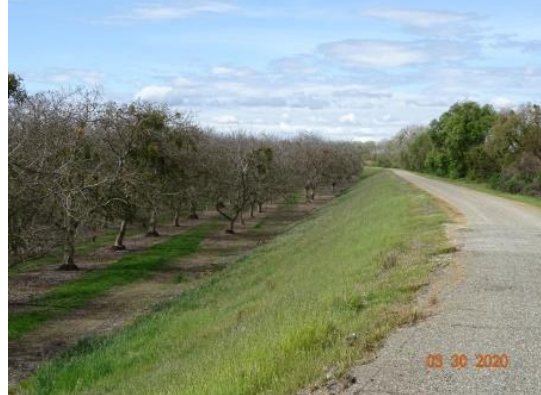
Photo 1 of 1 : SP\_2020\_RD1001\_37\_6\_20200407\_00028.jpg

LM Start	0.01	Rating **	A	Issue No.	6
LM End	12.54	Issue Type +	Ma	Location *	LS
Category	Earthen Levee			GPS Latitude/Longitude	
				Start	End
Item	Vegetation			39.006578 °	38.941648 °
				-121.375132 °	-121.567352 °
DWR ID	DWR_RD1001_03_s_2020_6				
Comment Code					
V1 : Control annual grass and weeds on the levee slopes and easements.					
Inspector Comment					
The annual vegetation is well maintained, Spring 2020.

View looking downstream landside at the well maintained annual vegetation, Spring 2020.

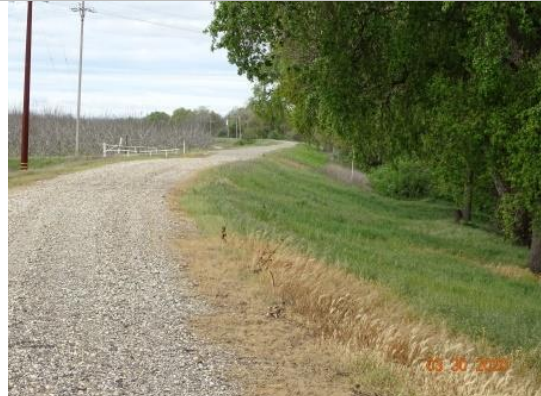
Photo 1 of 1 : SP\_2020\_RD1001\_37\_8\_20200407\_00027.jpg

LM Start	0.01	Rating **	A	Issue No.	8
LM End	12.54	Issue Type +	Ma	Location *	WS
Category	Earthen Levee			GPS Latitude/Longitude	
				Start	End
Item	Vegetation			39.006578 °	38.941648 °
				-121.375132 °	-121.567352 °
DWR ID	DWR_RD1001_03_s_2020_8				
Comment Code					
V1 : Control annual grass and weeds on the levee slopes and easements.					
Inspector Comment					
The annual vegetation is well maintained, Spring 2020.

View looking downstream waterside at the well maintained annual vegetation, Spring 2020.

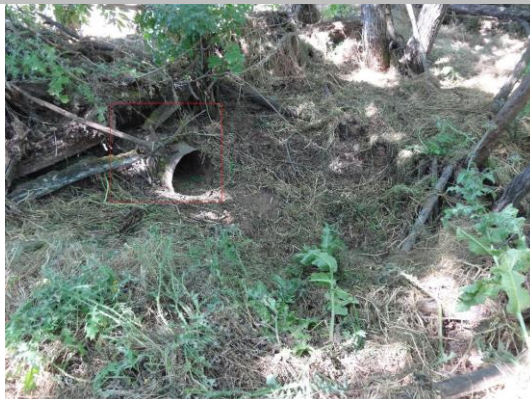
Photo 1 of 3 : UCIP\_SP\_2020\_14128\_23308.jpg

LM Start	0.88	Rating **	M	Issue No.	911
LM End	0.88	Issue Type +	En	Location *	
Category	Supplemental			GPS Latitude/Longitude	
				Start	End
Item	DWR UCIP Field Study			39.006508 °	39.006508 °
				-121.391086 °	-121.391086 °
DWR ID	22549				
Comment Code					
Inspector Comment					
DS_ID:22549 FS_ID:14128 EP_NO: 958 Repair Type: Non-Urgent Crossing Status: Found UCIP Comments: 05/21/2013 - slide gate on WS not found- needs abandoned properly. (P. Amatya - DWR UCIP) FIELD_STRUCT_DESC: *ABANDONED* 24-inch irrigation pipe of an unknown material through the levee, at an unknown depth. Slide gate on the waterside (WS) end. (24-inch irrigation pipe authorized under Permit No. 958, 1944 - Frank B. Lichty and Maggie Lichty). FS Date: 5/21/2013

WS- abandoned CMP on berm of the levee.

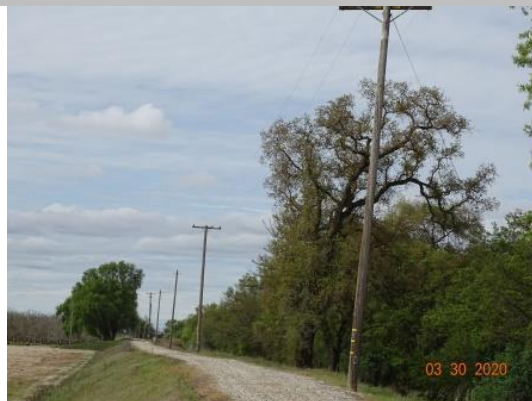
Photo 1 of 1 : SP\_2020\_RD1001\_37\_3\_20200407\_00029.jpg

LM Start	1.16	Rating **	M	Issue No.	3
LM End	1.78	Issue Type +	En	Location *	WS
Category	Earthen Levee			GPS Latitude/Longitude	
				Start	End
Item	Encroachments			39.005730 °	38.999534 °
				-121.396111 °	-121.404395 °
DWR ID	DWR_RD1001_03_s_2012_3				
Comment Code					
PO : Pole					
Inspector Comment					
Unpermitted Power Poles on the crown along waterside shoulder.

View of Power Poles along waterside shoulder, Spring 2020.

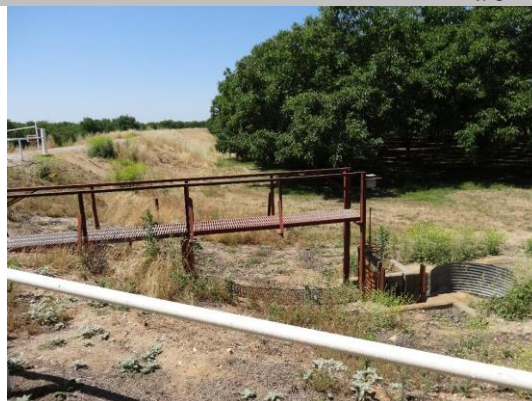
Photo 1 of 3 : UCIP\_SP\_2020\_41727\_23325.jpg

WS- steel walkway, CMP and concrete headwall

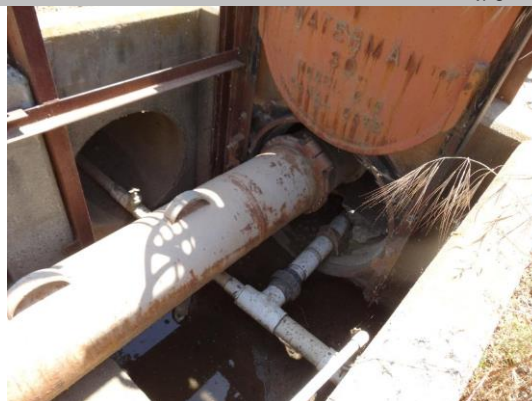
Photo 3 of 3 : UCIP\_SP\_2020\_41727\_23323.jpg

DS\_ID:22561  
FS\_ID:41727  
EP\_NO: 4505  
Repair Type: Non-Urgent  
Crossing Status: Found  
UCIP Comments: 05/21/2013 Two small steel pipes sleeved through 30-inch CMP may be a compliance issue as slide gate cannot close.- this may have been converted into drainage pipe (?) - big CMP standpipe on WS. (P. Amatya - DWR UCIP)  
FIELD\_STRUCT\_DESC: 30-inch concrete encased corrugated metal irrigation pipe through the levee, 11 feet below the crown. Concrete headwall and slide gate at the waterside (WS) toe, removed. Metal walkway on the WS to the slide gate. Pipe discharges into a 48-inch concrete standpipe at the landside (LS) toe. Two vertical pumps. (30-inch concrete encased corrugated metal irrigation pipe authorized under Permit No. 4505, 1964 - State of California, Department of Public Works, Division of Highways). [Additional Reference(s): DWR Levee Log, 1993. USACE Sacramento O&M Manual 141.1, August 1955, (Station 949+00), 30-inch steel pipe referenced].

WS- two steel pipes are sleeved through 30-inch CMP.

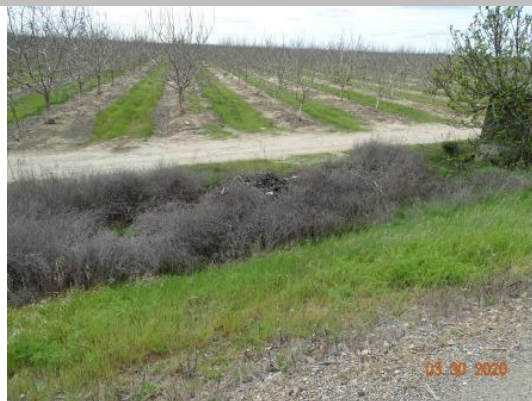
Photo 1 of 1 : SP\_2020\_RD1001\_37\_16\_20200407\_00032.jpg

LM Start	2.58	Rating **	M	Issue No.	16
LM End	2.58	Issue Type +	En	Location *	LS
Category	Earthen Levee			GPS Latitude/Longitude	
				Start	End
Item	Encroachments			38.995610 °	38.995610 °
				-121.417846 °	-121.417846 °
DWR ID	DWR_RD1001_03_s_2017_16				
Comment Code					
PR : Prunings					
Inspector Comment					
Prunings at levee toe need to be removed, Spring 2020.

View looking downstream landside at debris and prunings at the levee toe, Spring 2020.

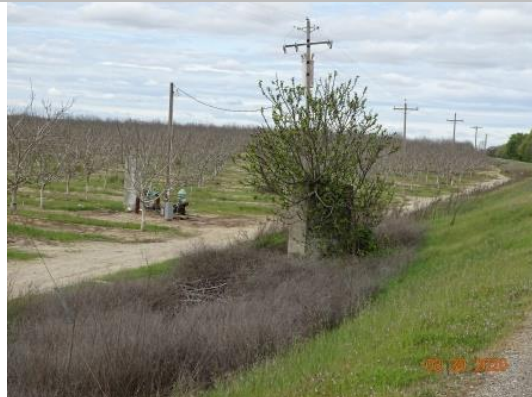
Photo 1 of 1 : SP\_2020\_RD1001\_37\_36\_20200407\_00030.jpg

LM Start	2.59	Rating **	M	Issue No.	36
LM End	2.59	Issue Type +	Ma	Location *	LS
Category	Earthen Levee			GPS Latitude/Longitude	
				Start	End
Item	Trim / Thin Trees			38.995583 °	38.995583 °
				-121.417995 °	-121.417995 °
DWR ID	DWR_RD1001_03_s_2015_36				
Comment Code					
T3 : Trim and thin trees to allow visibility of the ground and room to flood fight.					
Inspector Comment					
Tree less than 4" in diameter should be removed, Spring 2020.

View of a small starter tree on landside slope looking downstream that is less than 4" in diameter, Spring 2020.

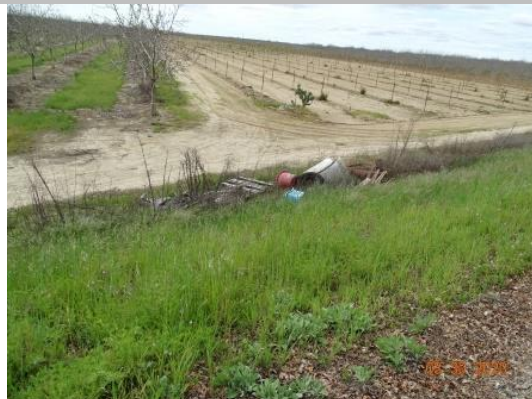
Photo 1 of 1 : SP\_2020\_RD1001\_37\_15\_20200407\_00033.jpg

LM Start	2.73	Rating **	M	Issue No.	15
LM End	2.78	Issue Type +	En	Location *	LS
Category	Earthen Levee			GPS Latitude/Longitude	
				Start	End
Item	Encroachments			38.995119 °	38.994920 °
				-121.420498 °	-121.421326 °
DWR ID	DWR_RD1001_03_s_2020_15				
Comment Code					
DE : Debris					
Inspector Comment					
Remove debris at levee toe, Spring 2020.

View looking downstream landside at debris and prunings at the levee toe, Spring 2020.

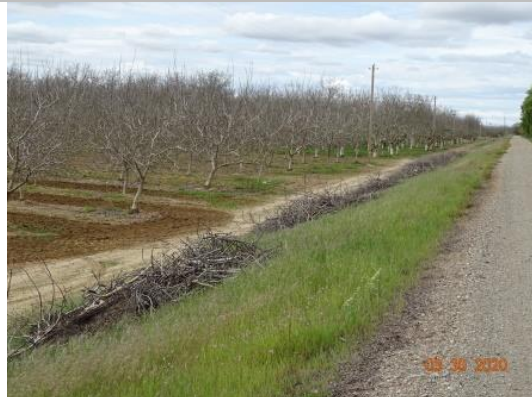
Photo 1 of 1 : SP\_2020\_RD1001\_37\_53\_20200407\_00035.jpg

LM Start	2.87	Rating **	M	Issue No.	53
LM End	2.95	Issue Type +	En	Location *	LS
Category	Earthen Levee			GPS Latitude/Longitude	
				Start	End
Item	Encroachments			38.994543 °	38.994211 °
				-121.422884 °	-121.424292 °
DWR ID	DWR_RD1001_03_f _ 2017_53				
Comment Code					
PR : Prunings					
Inspector Comment					
Remove prunings from levee toe, Spring 2020.

View looking downstream landside of prunings on levee slope, Spring 2020.

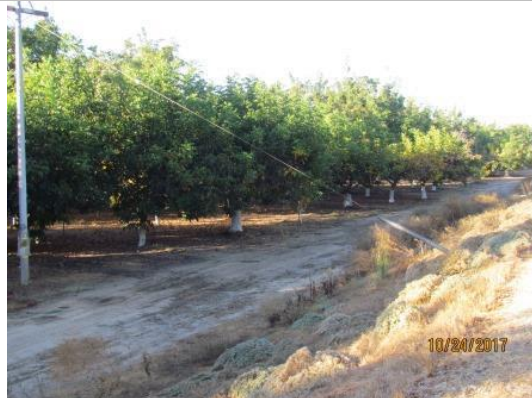
Photo 1 of 1 : SP\_2020\_RD1001\_37\_54\_20200227\_00018.jpg

LM Start	3.03	Rating **	M	Issue No.	54
LM End	3.03	Issue Type +	En	Location *	LS
Category	Earthen Levee			GPS Latitude/Longitude	
				Start	End
Item	Encroachments			38.993838 °	38.993838 °
				-121.425829 °	-121.425829 °
DWR ID	DWR_RD1001_03_f_2017_54				
Comment Code					
PO : Pole					
Inspector Comment					
There is a guy wire in the levee slope near the crown.

View looking downstream landside of a guy wire into the levee slope.

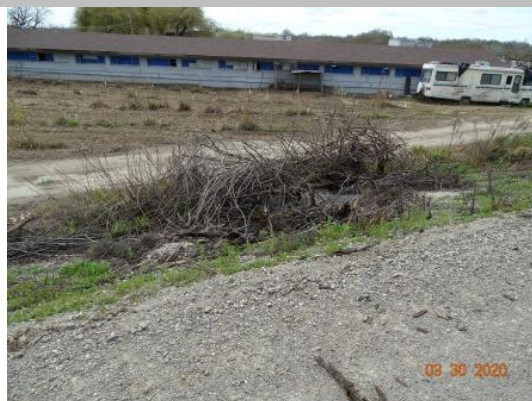
Photo 1 of 1 : SP\_2020\_RD1001\_37\_17\_20200407\_00036.jpg

LM Start	3.50	Rating **	M	Issue No.	17
LM End	3.50	Issue Type +	En	Location *	LS
Category	Earthen Levee			GPS Latitude/Longitude	
				Start	End
Item	Encroachments			38.991845 °	38.991845 °
				-121.434122 °	-121.434122 °
DWR ID	DWR_RD1001_03_s_2020_17				
Comment Code					
PR : Prunings					
Inspector Comment					
Remove prunings from levee toe, Spring 2020.

View looking downstream landside of prunings on levee slope, Spring 2020.

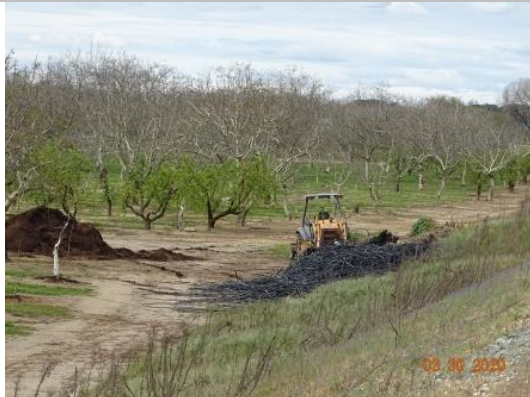
Photo 1 of 1 : SP\_2020\_RD1001\_37\_35\_20200407\_00039.jpg

LM Start	4.47	Rating **	M	Issue No.	35
LM End	4.47	Issue Type +	En	Location *	LS
Category	Earthen Levee			GPS Latitude/Longitude	
				Start	End
Item	Encroachments			38.991864 °	38.991864 °
				-121.451770 °	-121.451770 °
DWR ID	DWR_RD1001_03_s_2017_35				
Comment Code					
LI : Landscape Irrigation					
Inspector Comment					
Remove drip irrigation along levee toe, Spring 2020.

View looking downstream landside of drip irrigation and trash on levee slope, Spring 2020.

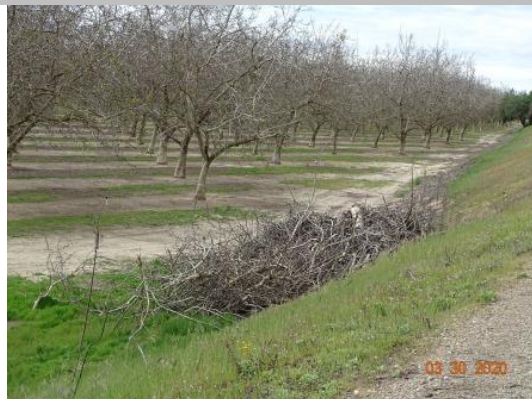
Photo 1 of 1 : SP\_2020\_RD1001\_37\_19\_20200407\_00040.jpg

LM Start	4.69	Rating **	M	Issue No.	19
LM End	4.69	Issue Type +	En	Location *	LS
Category	Earthen Levee			GPS Latitude/Longitude	
				Start	End
Item	Encroachments			38.991415 °	38.991415 °
				-121.455852 °	-121.455852 °
DWR ID	DWR_RD1001_03_s_2020_19				
Comment Code					
PR : Prunings					
Inspector Comment					
Remove prunings from levee toe and slope, Spring 2020.

View looking downstream landside at prunings on the levee toe and slope, Spring 2020.

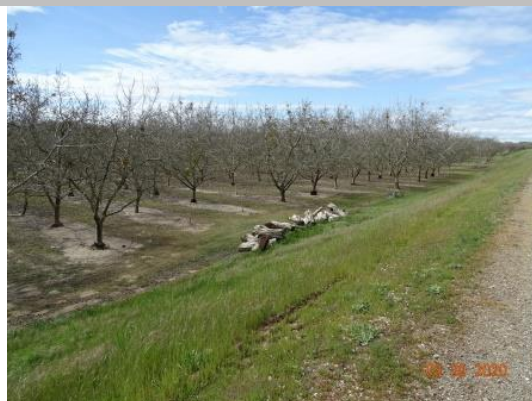
Photo 1 of 1 : SP\_2020\_RD1001\_37\_23\_20200408\_00042.jpg

LM Start	6.85	Rating **	M	Issue No.	23
LM End	6.85	Issue Type +	En	Location *	LS
Category	Earthen Levee			GPS Latitude/Longitude	
				Start	End
Item	Encroachments			38.983327 °	38.983327 °
				-121.494379 °	-121.494379 °
DWR ID	DWR_RD1001_03_s_2020_23				
Comment Code					
PR : Prunings					
Inspector Comment					
Remove stumps from levee toe, Spring 2020.

View looking downstream landside at stumps at the levee toe, Spring 2020.

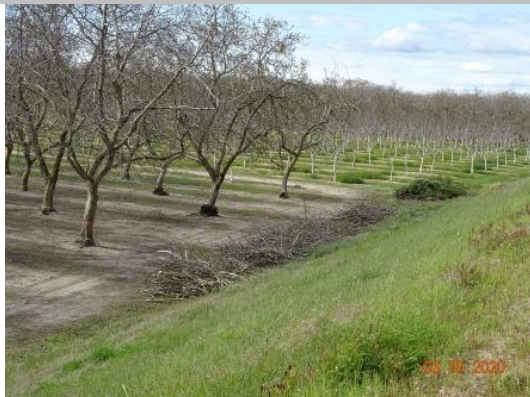
Photo 1 of 1 : SP\_2020\_RD1001\_37\_25\_20200408\_00043.jpg

LM Start	7.04	Rating **	M	Issue No.	25
LM End	7.07	Issue Type +	En	Location *	LS
Category	Earthen Levee			GPS Latitude/Longitude	
				Start	End
Item	Encroachments			38.982904 °	38.982849 °
				-121.497968 °	-121.498471 °
DWR ID	DWR_RD1001_03_s_2020_25				
Comment Code					
PR : Prunings					
Inspector Comment					
Remove prunings from levee toe, Spring 2020.

View looking downstream landside at prunings at levee toe, Spring 2020.

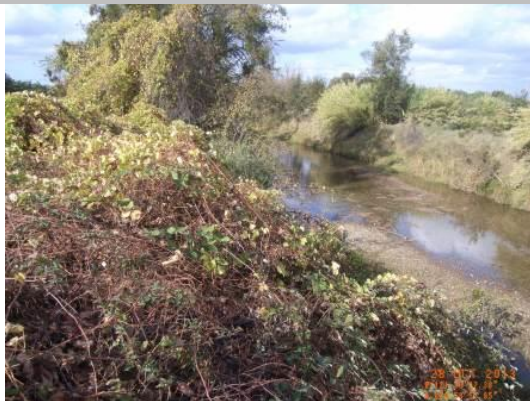
Photo 1 of 1 : SP\_2020\_RD1001\_37\_13\_20200227\_00009.jpg

LM Start	7.22	Rating **	A/W	Issue No.	13
LM End	7.31	Issue Type +	Ma	Location *	WS
Category	Supplemental			GPS Latitude/Longitude	
				Start	End
Item	2017 USACE Erosion Survey			38.982737 °	38.982572 °
				-121.501144 °	-121.502797 °
DWR ID	DWR_RD1001_03_f_2018_13				
Comment Code					
Inspector Comment					
2017 Site ID: BER 5.7 L					
Status: Eroding					
2017 Field Notes: Minor new erosion observed.					
Site History: 2008 - Sandy/silty banks with rotational slab failures					
creating near vertical bank with pop-outs due to tree failures. Narrow					
berm.

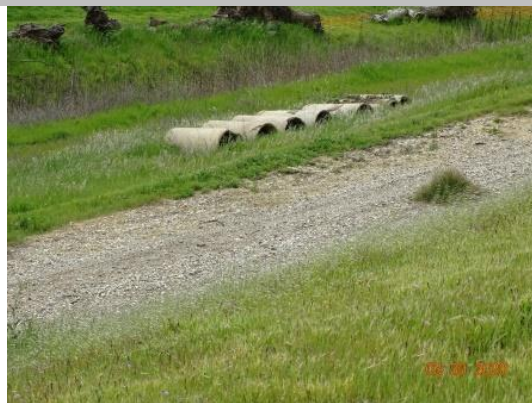
Photo 1 of 1 : SP\_2020\_RD1001\_37\_29\_20200409\_00045.jpg

LM Start	9.77	Rating **	M	Issue No.	29
LM End	9.77	Issue Type +	En	Location *	LS
Category	Earthen Levee			GPS Latitude/Longitude	
				Start	End
Item	Encroachments			38.969719 °	38.969719 °
				-121.538892 °	-121.538892 °
DWR ID	DWR_RD1001_03_s_2020_29				
Comment Code					
MA : Material					
Inspector Comment					
Remove the concrete pipe section from the levee toe, Spring 2020.

View looking downstream landside at several concrete pipe sections at the levee toe, Spring 2020.

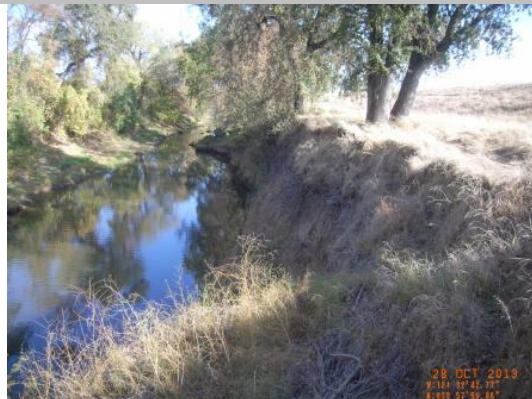
Photo 1 of 1 : SP\_2020\_RD1001\_37\_12\_20200227\_00008.jpg

LM Start	10.36	Rating **	A/W	Issue No.	12
LM End	10.40	Issue Type +	Ma	Location *	WS
Category	Supplemental			GPS Latitude/Longitude	
				Start	End
Item	2017 USACE Erosion Survey			38.964583 °	38.964010 °
				-121.544967 °	-121.545228 °
DWR ID	DWR_RD1001_03_f_2018_12				
Comment Code					
Inspector Comment					
2017 Site ID: BER 2.5 L					
Status: Eroding					
2017 Field Notes: Erosion pockets have expanded					
Site History: 2011 - Large section of bank has slumped off. RD has					
flagged and appears to be watching. 2012 - Slopes slightly steeper.					
2013 - Minor new erosion observed.

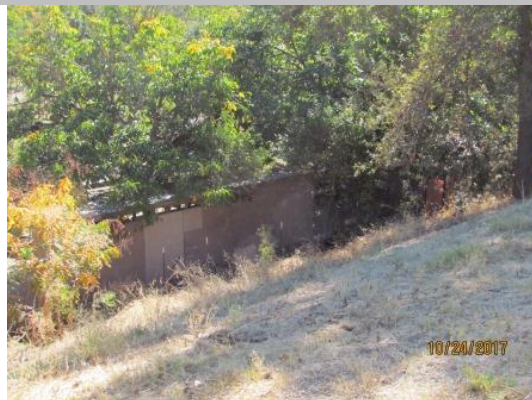
Photo 1 of 1 : SP\_2020\_RD1001\_37\_11\_20200227\_00007.jpg

LM Start	10.49	Rating **	U	Issue No.	11
LM End	10.49	Issue Type +	En	Location *	LS
Category	Earthen Levee			GPS Latitude/Longitude	
				Start	End
Item	Encroachments			38.962770 °	38.962770 °
				-121.545741 °	-121.545741 °
DWR ID	DWR_RD1001_03_f_2015_11				
Comment Code					
BU : Building					
Inspector Comment					
Small sheds are at levee toe.

View of building at the landside toe.

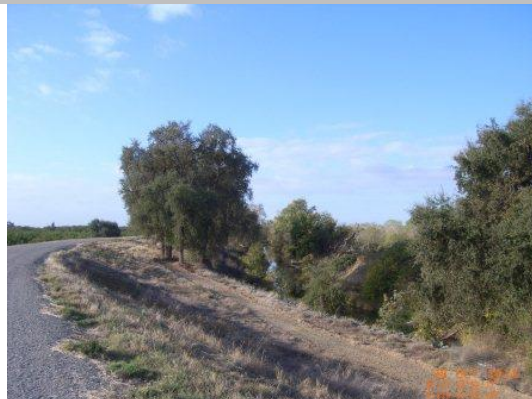
Photo 1 of 1 : SP\_2020\_RD1001\_37\_10\_20200227\_00006.jpg

LM Start	11.08	Rating **	A/W	Issue No.	10
LM End	11.16	Issue Type +	Ma	Location *	WS
Category	Supplemental			GPS Latitude/Longitude	
				Start	End
Item	2017 USACE Erosion Survey			38.955070 °	38.954227 °
				-121.549528 °	-121.550592 °
DWR ID	DWR_RD1001_03_f_2018_10				
Comment Code					
Inspector Comment					
2017 Site ID: BER 1.9 L					
Status: Eroding					
2017 Field Notes: Minor new erosion observed.					
Site History: 2011 - Large slumped sections of bank. 2012 - Slopes slightly steeper.

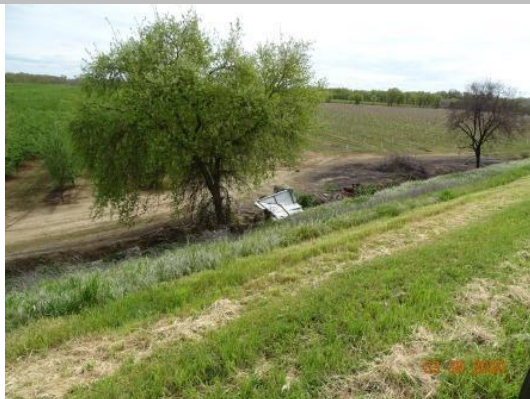
Photo 1 of 1 : SP\_2020\_RD1001\_37\_14\_20200409\_00046.jpg

LM Start	12.25	Rating **	M	Issue No.	14
LM End	12.25	Issue Type +	En	Location *	LS
Category	Earthen Levee			GPS Latitude/Longitude	
				Start	End
Item	Encroachments			38.945301 °	38.945301 °
				-121.564826 °	-121.564826 °
DWR ID	DWR_RD1001_03_s_2019_14				
Comment Code					
DE : Debris					
Inspector Comment					
Prunings have been burned but debris at levee toe needs to be removed, Spring 2020.

View looking downstream landside at debris that has been piled up on the levee toe, Spring 2020.

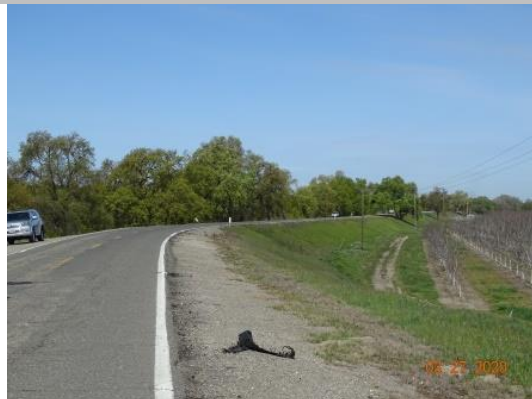
Photo 1 of 1 : SP\_2020\_RD1001\_38\_58\_20200406\_00069.jpg

LM Start	0.01	Rating **	A	Issue No.	58
LM End	13.27	Issue Type +	Ma	Location *	LS
Category	Earthen Levee			GPS Latitude/Longitude	
				Start	End
Item	Vegetation			38.940950 °	38.781209 °
				-121.567646 °	-121.605554 °
DWR ID	DWR_RD1001_04_s _ 2020_58				
Comment Code					
V1 : Control annual grass and weeds on the levee slopes and easements.					
Inspector Comment					
The annual vegetation is well maintained, Spring 2020.

View looking upstream landside at the well maintained annual vegetation, Spring 2020.

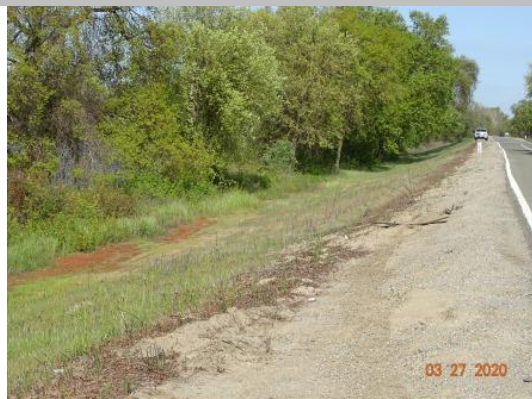
Photo 1 of 1 : SP\_2020\_RD1001\_38\_59\_20200406\_00070.jpg

LM Start	0.01	Rating **	A	Issue No.	59
LM End	13.27	Issue Type +	Ma	Location *	WS
Category	Earthen Levee			GPS Latitude/Longitude	
				Start	End
Item	Vegetation			38.940950 °	38.781209 °
				-121.567646 °	-121.605553 °
DWR ID	DWR_RD1001_04_s _ 2020_59				
Comment Code					
V1 : Control annual grass and weeds on the levee slopes and easements.					
Inspector Comment					
The annual vegetation is well maintained, Spring 2020.

View looking upstream waterside at the well maintained annual vegetation, Spring 2020.

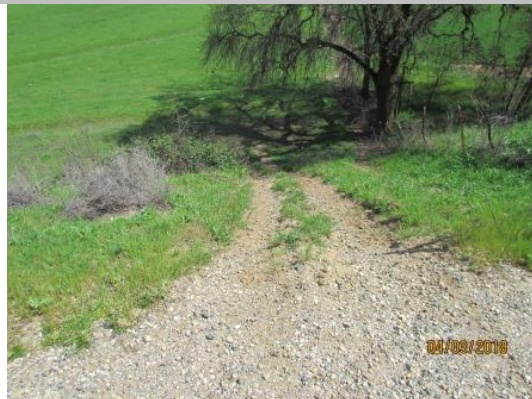
Photo 1 of 1 : SP\_2020\_RD1001\_38\_68\_20200227\_00025.jpg

LM Start	0.55	Rating **	M	Issue No.	68
LM End	0.55	Issue Type +	Ma	Location *	LS
Category	Earthen Levee			GPS Latitude/Longitude	
				Start	End
Item	Slope Stability			38.933299 °	38.933299 °
				-121.567069 °	-121.567069 °
DWR ID	DWR_RD1001_04_s_2016_68				
Comment Code					
S3 : Repair the levee slope damaged by vehicle traffic and prevent access where possible.					
Inspector Comment					
Repair slope damage caused by ATV.

View of ruts caused by vehicle on the landside levee slope.

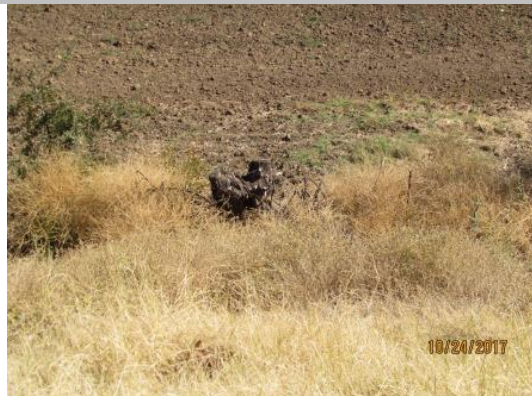
Photo 1 of 1 : SP\_2020\_RD1001\_38\_69\_20200227\_00026.jpg

LM Start	1.06	Rating **	N	Issue No.	69
LM End	1.06	Issue Type +	Ma	Location *	LS
Category	Earthen Levee			GPS Latitude/Longitude	
				Start	End
Item	Trim / Thin Trees			38.926128 °	38.926128 °
				-121.568241 °	-121.568241 °
DWR ID	DWR_RD1001_04_s_2016_69				
Comment Code					
T5 : Tree stumps.					
Inspector Comment					
Remove stump from levee toe, Fall 2019.

View of landside toe of a stump that needs to be removed.

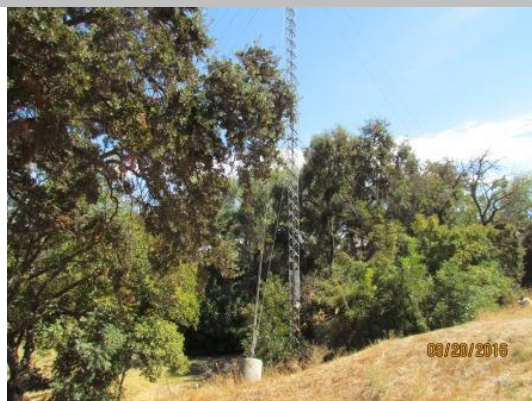
Photo 1 of 1 : SP\_2020\_RD1001\_38\_19\_20200227\_00008.jpg

LM Start	2.27	Rating **	M	Issue No.	19
LM End	2.27	Issue Type +	En	Location *	LS
Category	Earthen Levee			GPS Latitude/Longitude	
				Start	End
Item	Encroachments			38.909790 °	38.909790 °
				-121.574449 °	-121.574449 °
DWR ID	DWR_RD1001_04_s_2013_19				
Comment Code					
PO : Pole					
Inspector Comment

View of unpermitted tower and guy wire on the levee slope.

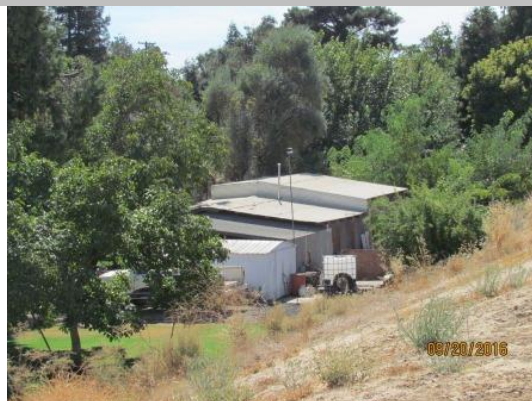
Photo 1 of 1 : SP\_2020\_RD1001\_38\_20\_20200227\_00009.jpg

LM Start	2.59	Rating **	M	Issue No.	20
LM End	2.59	Issue Type +	En	Location *	LS
Category	Earthen Levee			GPS Latitude/Longitude	
				Start	End
Item	Encroachments			38.905773 °	38.905773 °
				-121.577164 °	-121.577164 °
DWR ID	DWR_RD1001_04_s_2013_20				
Comment Code					
BU : Building					
Inspector Comment

View of buildings along the toe within the easement of the landside

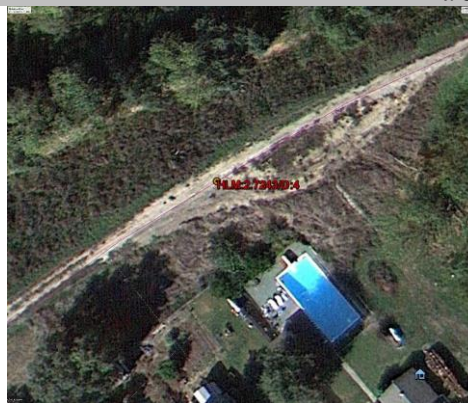
Photo 1 of 3 : UCIP\_SP\_2020\_55162\_24126.jpg

Comment Code						
Inspector Comment						
DS_ID:22568 FS_ID:55162 EP_NO: N/A Repair Type: Non-Urgent Crossing Status: Indicator Found UCIP Comments: 08/21/2019 Crossing remains Non-Urgent, unable to confirm if pipe found on the WS is the same pipe referenced in the DWR Levee Log. Need to contact property owner to determine if pipe still exists. (O. Magana - DWR UCIP)05/16/2013 Dense vegetation on slopes should be cleared. (P. Amatya - DWR UCIP) FIELD_STRUCT_DESC: 4-inch steel swimming pool drainage pipe through the levee, 3 feet below the crown. Open on the waterside (WS) end. Swimming pool on the landside (LS) toe. (Nate Wise). [Additional Reference(s): DWR Levee Log, 1993]. FS Date: 8/21/2019 12:59:00 PM

LS- only a private swimming pool found.

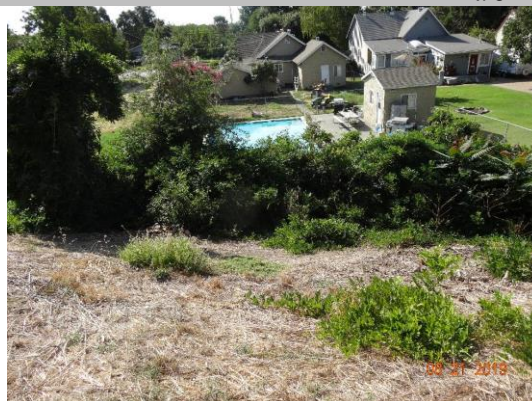
Photo 2 of 3 : UCIP\_SP\_2020\_55162\_81125.jpg

LS view: overview of LS.

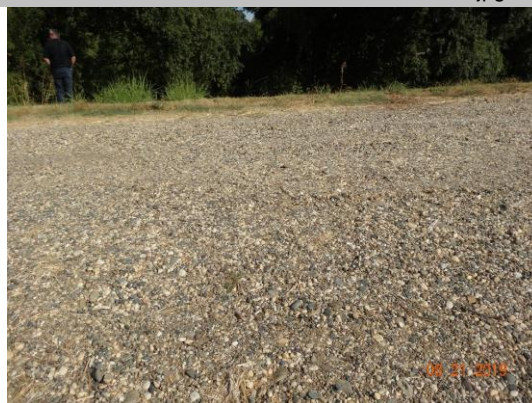
Photo 3 of 3 : UCIP\_SP\_2020\_55162\_81126.jpg

Overview of levee crown where pipe should cross the levee.

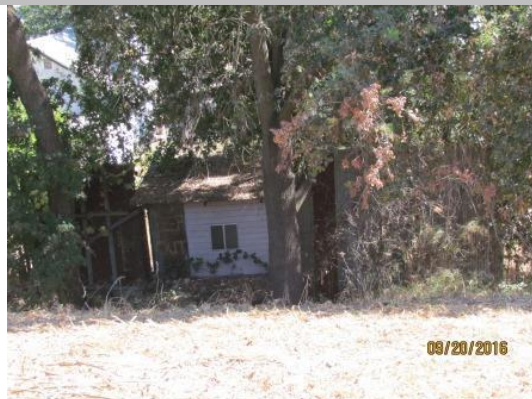
Photo 1 of 1 : SP\_2020\_RD1001\_38\_32\_20200227\_00015.jpg

LM Start	2.70	Rating **	M	Issue No.	32
LM End	2.70	Issue Type +	En	Location *	LS
Category	Earthen Levee			GPS Latitude/Longitude	
				Start	End
Item	Encroachments			38.904898 °	38.904898 °
				-121.578829 °	-121.578829 °
DWR ID	DWR_RD1001_04_f _ 2016_32				
Comment Code					
BU : Building					
Inspector Comment

View of shed at landside levee toe in the easement.

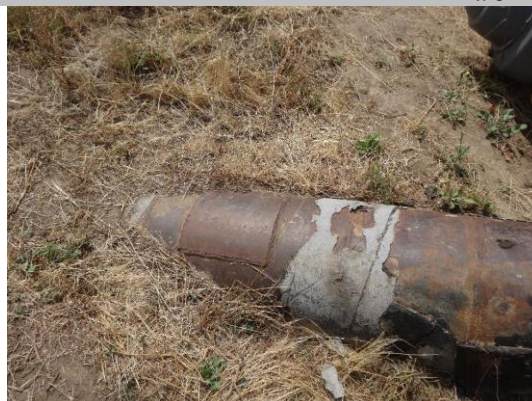
Photo 2 of 3 : UCIP\_SP\_2020\_55167\_24120.jpg

Comment Code					
Inspector Comment					
DS_ID:22571 FS_ID:55167 EP_NO: N/A Repair Type: Urgent Crossing Status: Found UCIP Comments: 08/21/2019 Crossing has been updated from No Action Needed to Urgent due to a scour section found at the WS toe. Pipe was running during inspection, no leaks were observed on the WS or LS. From the river survey, a scour section was visible at WS toe. Recommend monitoring site and coordinating with LMA to evaluate extent of damage. (O. Magana - DWR UCIP)05/16/2013 - working during field survey (P. Amatya - DWR UCIP) FIELD_STRUCT_DESC: 18-inch steel irrigation pipe through the levee, 3.5 feet below the crown. 40-horsepower slant pump mounted on the waterside (WS) slope. Siphon breaker on the landside (LS) slope. Pipe discharges into a 36-inch concrete standpipe on the LS. 1.25-inch electrical conduit through the levee, 3 feet below the crown. (no permit found authorizing 18-inch pipe; 40-horsepower slant pump and reinstallation of LS pipe authorized under Permit No. 5342, 1966 - Esther Scheiber). [Additional Reference(s): DWR Levee Log, 1993]. FS Date: 8/21/2019 1:01:00 PM

WS- steel pipe daylights at levee slope.

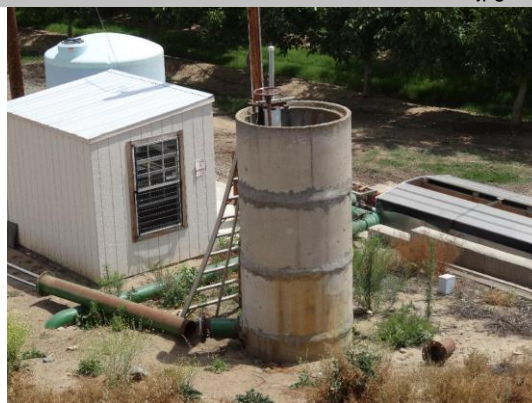
Photo 3 of 3 : UCIP\_SP\_2020\_55167\_24122.jpg

LS- concrete stand pipe at levee toe.

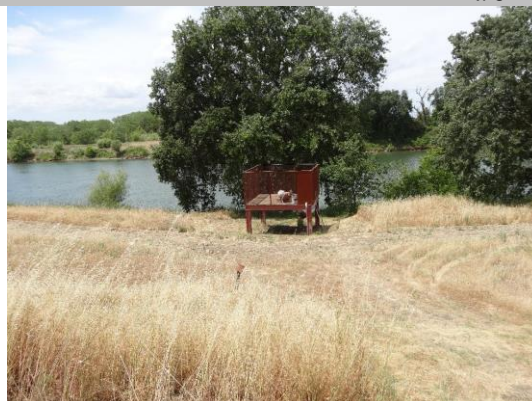
Photo 1 of 3 : UCIP\_SP\_2020\_55170\_24107.jpg

DS\_ID:22573  
FS\_ID:55170  
EP\_NO: 10389-A  
Repair Type: Non-Urgent  
Crossing Status: Found  
UCIP Comments: 08/21/2019 Crossing remains Non-Urgent; Work still pending (logged under maintenance compliance issue), project is waiting on Status of Cultural report for Encroachment Permit Application No. 10389-A-1. Work involves modifying existing pumping plant removing and replacing existing 12-inch dia pressurized water pipe and electrical conduit, installing a 5-foot x 5-foot vault housing, new siphon breaker and butterfly valve, and name change. (O. Magana - DWR UCIP)01/24/2019 Project modification logged under Permit 10389-A-1 proposes removing and replacing existing 12-inch pressurized water pipe and conduit. Need to determine construction start date and obtain as-built drawing for new pipe. Pending actions: need to issue new UCIP dsid for new pipe and retire current dsid 22573. (O. Magana - DWR UCIP)

05/16/2013 - water leakage causes erosion on LS slope.- may be pressure breaker valve not closed properly on LS.- a 36-inch concrete standpipe at the landward toe not found. (P. Amatya - DWR UCIP)  
FIELD\_STRUCT\_DESC: 12-inch irrigation discharge pipe of an unknown material through the levee, 10 feet below the crown. 30-horsepower slant pump on the riverbank. Siphon breaker in a 24-inch corrugated metal pipe (CMP) riser on the landside (LS) slope. Pipe discharges into a 36-inch concrete standpipe at the LS toe. Pipe installed by USACE in 1963. Switch panel and service pole at the LS toe. (12-inch pipe and a 30-horsepower slant pump authorized under Permit No. 10389-A, 1974 - Pluma Orchards, also includes removal of existing pipe). [Additional Reference(s): DWR Levee Log, 1993].  
FS Date: 8/21/2019 1:06:00 PM

WS- slanted pump station on steel platform on levee berm.

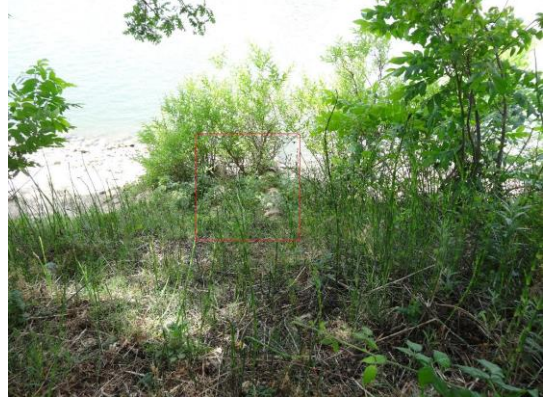
Photo 2 of 3 : UCIP\_SP\_2020\_55170\_24106.jpg

WS- inlet pipe on the river bank.

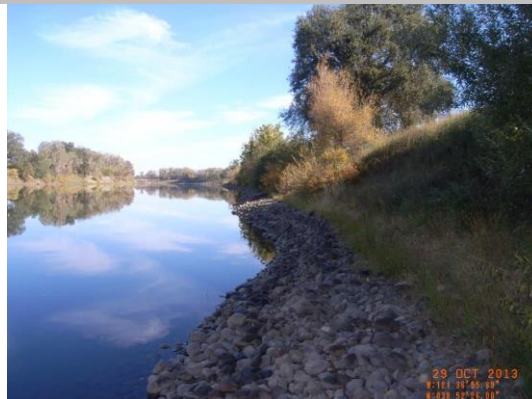
Photo 1 of 1 : SP\_2020\_RD1001\_38\_28\_20200227\_00012.jpg

LM Start	5.80	Rating **	A/W	Issue No.	28
LM End	5.93	Issue Type +	Ma	Location *	WS
Category	Supplemental			GPS Latitude/Longitude	
				Start	End
Item	2017 USACE Erosion Survey			38.874113 °	38.872373 °
				-121.615380 °	-121.616504 °
DWR ID	DWR_RD1001_04_f_2018_28				
Comment Code					
Inspector Comment					
2017 Site ID: FHR 6.6 L					
Status: Eroding					
2017 Field Notes: Sandy bank slope is unraveling.					
Site History: 2011 - Erosion pockets from tree popouts. Sections of the lower bank have slumped off. 2013 - Scallop from tree popouts no longer visible on site. Minor new erosion at the middle of the bank.					
2015 - Fres erosion from human usage.

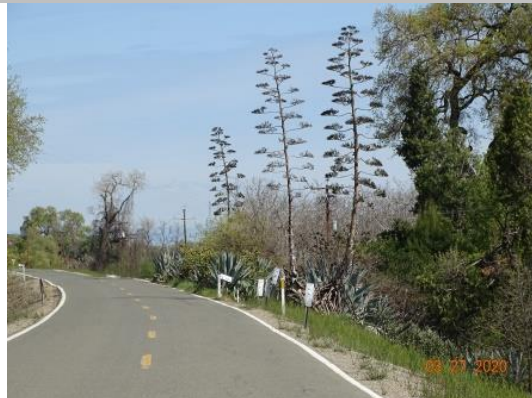
Photo 1 of 1 : SP\_2020\_RD1001\_38\_17\_20200407\_00073.jpg

LM Start	6.39	Rating **	U	Issue No.	17
LM End	6.46	Issue Type +	En	Location *	LS
Category	Earthen Levee			GPS Latitude/Longitude	
				Start	End
Item	Vegetation			38.866032 °	38.865195 °
				-121.619489 °	-121.620017 °
DWR ID	DWR_RD1001_04_s_2012_17				
Comment Code					
V6 : Landscaping					
Inspector Comment					
Home owners landscaping should be removed, Spring 2020.

View looking upstream landside of landscaping vegetation on the shoulder and levee slope, Spring 2020.
